**USE OF EXAR'S ST16C2550 WITH LINUX 2.4.X & 2.6.X OPERATING SYSTEMS,
PHOENIX BIOS VERSION 4.0 RELEASE 6.0 AND WINDOWS OPERATING SYSTEMS****1.0 INTRODUCTION**

The following information is an application consideration in regards to the use of the ST16C2550 family of devices (ST16C2450, ST16C2550 and ST16C2552) with top mark date code of "A2 YYWW". This family will be referred to as the ST16C2550 "A2" device in the remainder of this application note.

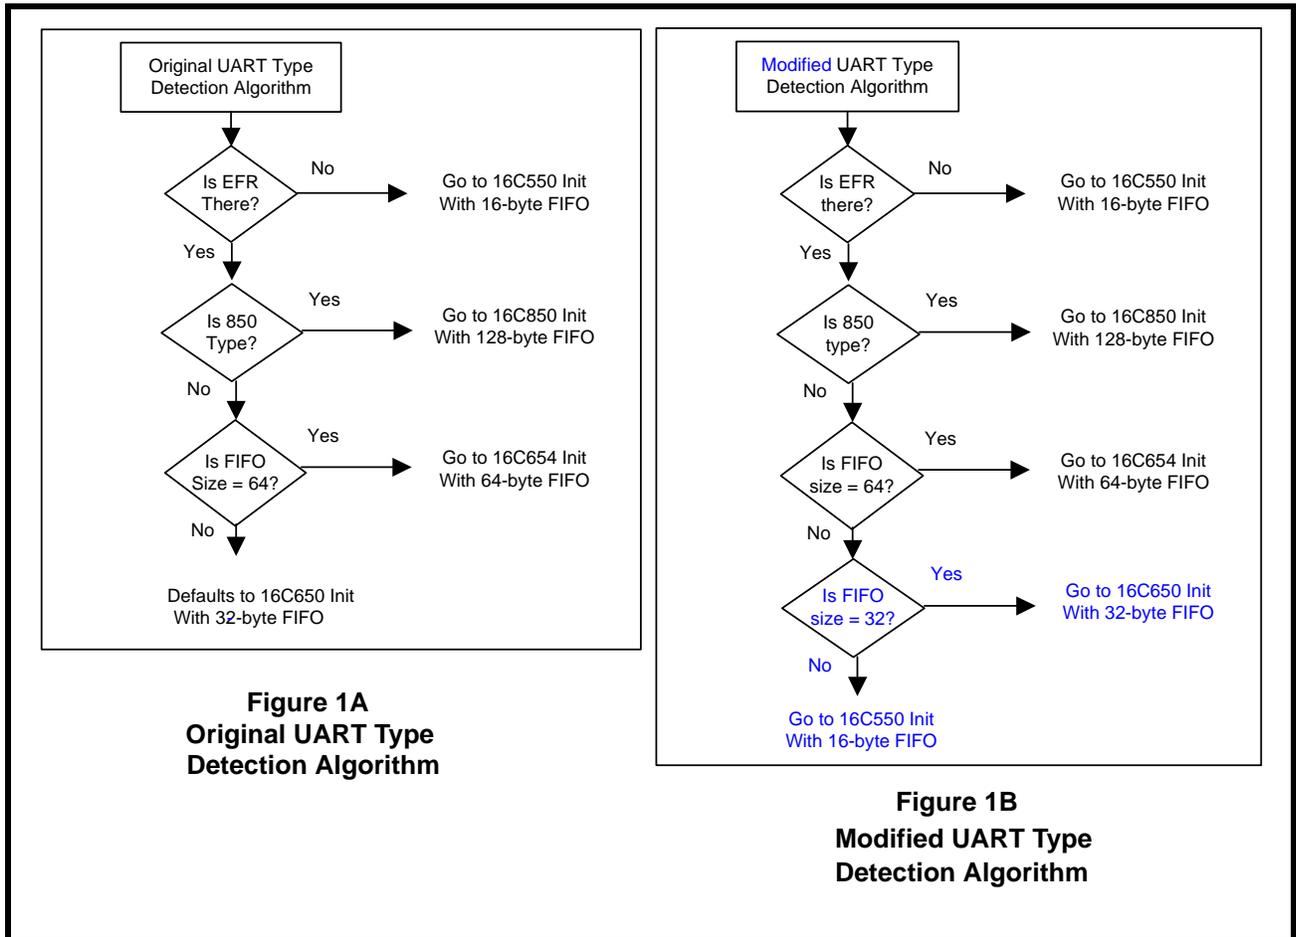
FIGURE 1. ORIGINAL AND MODIFIED UART TYPE DETECTION IN LINUX OPERATING SYSTEM KERNELS 2.4.x & 2.6.x

The Linux kernel (2.4.x and 2.6.x) identifies the ST16C2550 "A2" as a 16C650A due to the presence of the EFR register and the UART type detection algorithm. As shown in Figure 1A, the kernel defaults to the 16C650A (or 16C650V2) UART type when:

- it detects the presence of the EFR register, and
- it does not detect a 16C850 UART type or a 64-byte FIFO.

Operating the device as a 16C650V2 will cause an overrun condition resulting in data errors, due to the absence of 32-byte FIFO. This issue can be resolved if the algorithm is modified as shown in Figure 1B.

This is a software fix for the Linux 2.4.x kernel. This fix involves modifying the serial.c file and re-compiling the kernel by following the 18 steps given below. After this fix, the ST16C2550 “A2” device will be correctly identified as 16550A type. There is no need for the software patch mentioned in Solution A, which modifies the '/etc/rc.serial' file.

```
if (size_fifo(info) == 64)
    state->type = PORT_16654;
else
    state->type = PORT_16650V2;
```

```
state->type = PORT_16654;
else if (size_fifo(info) == 32) {
state->type = PORT_16650V2;
else
state->type = PORT_16550A;
}
```

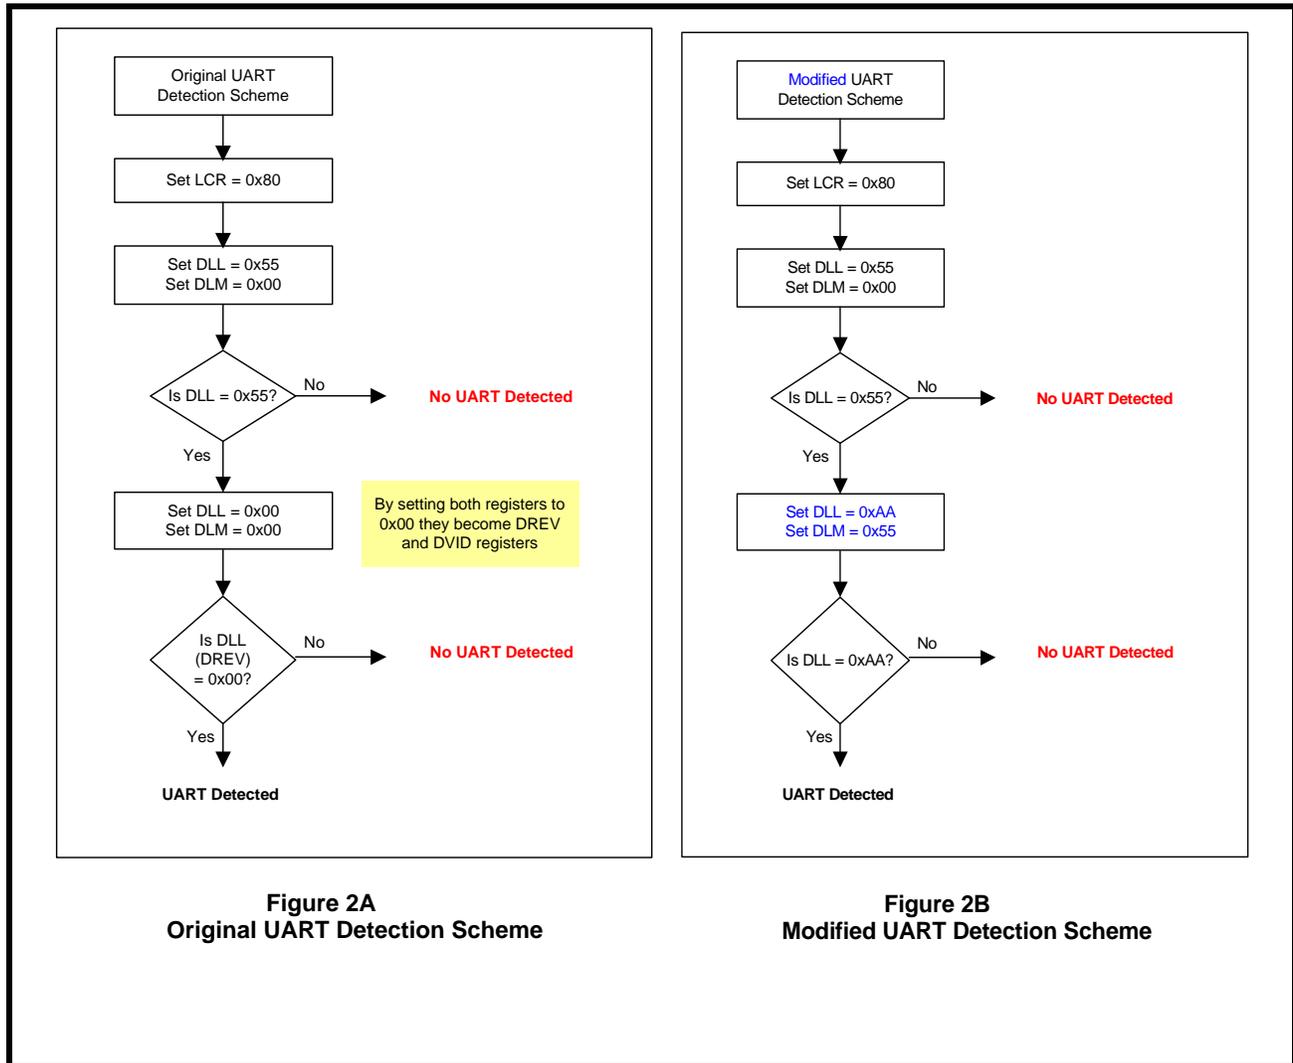
FIGURE 2. ORIGINAL AND MODIFIED UART DETECTION SCHEMES IN PHOENIX BIOS VERSION 4.0 RELEASE 6.0

The Phoenix BIOS version 4.0 release 6.0 uses a UART type detection algorithm (Figure 2A) that includes writing 0x00 to both DLL and DLM registers causing a detection error. When 0x00 is written into both DLL and DLM registers, the following read operations of DLL and DLM registers will return the value of DVID (0x02) and DREV (0x01), respectively, instead of the expected 0x00. If this algorithm is modified as shown in Figure 2B, this detection error can be eliminated. At the time of this publication, it has been observed that when a Windows O/S is used with this BIOS version, the Windows O/S performs its own detection of UARTs, thereby correcting the BIOS detection error, and the system operates properly.

- 1) Write 0x80 to LCR register; // Enable access to baud rate registers DLL & DLM in the shadow register page.
- 2) Write 0x55 to DLL;
- 3) Write 0x00 to DLM;
- 4) Read DLL; // Expect a value of 0x55. If data is correct, continue
- 5) Write 0x00 to DLL;
- 6) Write 0x00 to DLM; // DLL becomes DREV and DLM becomes DVID
- 7) Read DLL; // Expect a value of 0x00. Correct data validates the presence of a serial port.
// "A2 YYWW" device fails this step because the value read is 0x01.
- 8) Write 0x00 to LCR; // Return to base register page.

This problem can be resolved by modifying the Phoenix BIOS by writing alternate values to DLL and DLM in steps 5) and 6) above. This will detect the two serial ports of the "A2" device correctly. For example, change the steps 5), 6) and 7) above as follows:

- 5) Write 0xAA to DLL;
- 6) Write 0x55 to DLM; // DLL and DLM stay as DLL and DLM
- 7) Read DLL; // Expect a value of 0xAA. Correct data validates the presence of a serial port.
// "A2 YYWW" device will pass this step correctly.
